Replacing the Tenor Clapper at Bampton August 2017

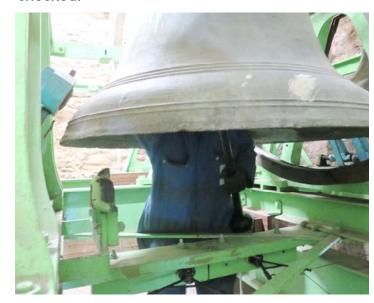
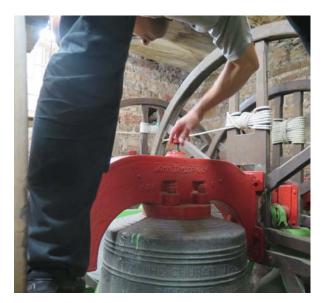
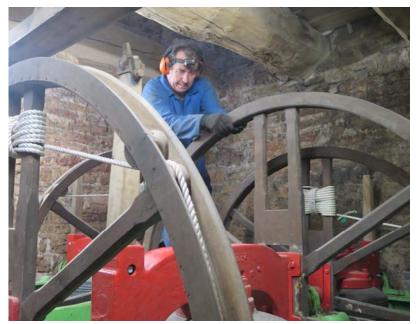
The bell hanger lifts the clapper feeding the fixed part through the crown of the bell and Mike replaces the nut to hold the clapper in place. The nut is then tightened and the clappering checked.

Nicholson Engineering Ltd were commissioned to repair the clapper. The break was too near the pivot for the two parts of the stem to be welded together and, as Nicholson didn't have a suitable replacement, a new clapper had to be cast. Nicholson were ready to replace the clapper on 22nd August. The replacement clapper and the bell ready to receive the replacement can be seen below. A new Tufnol bush mounted in neoprene rubber has been fitted together with a stainless steel hinge pin.

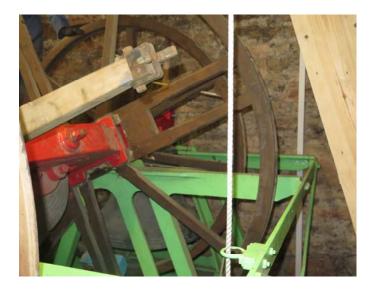
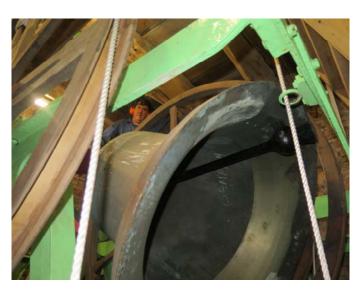
The bell hanger starts to swing the bell by pulling on the wheel. Note that the bell rope has been removed to prevent it becoming entangled round the headstock as the bell swings to and fro. The bell hanger continues to pull on the wheel raising the bell higher and higher...

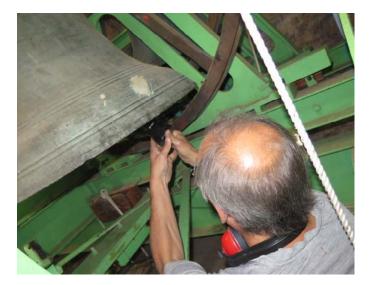
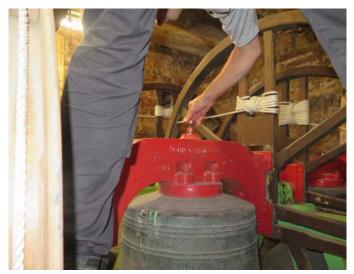
It was nearly right the first time and only needed a small adjustment which was made by pushing the fixed part of the clapper over in the hole through the crown whilst Mike held the moving part againt the bell to ensure that it didn't turn. And finally the lock nut was put on and the rope replaced.
